## STORMWATER POLLUTION PREVENTION PLAN INSPECTION REPORT

Name of Project: 7100 Husker Circle - Enterprise Location of Project: 7100 Husker Circle, Lincoln, Nebraska

Rent-a-Car

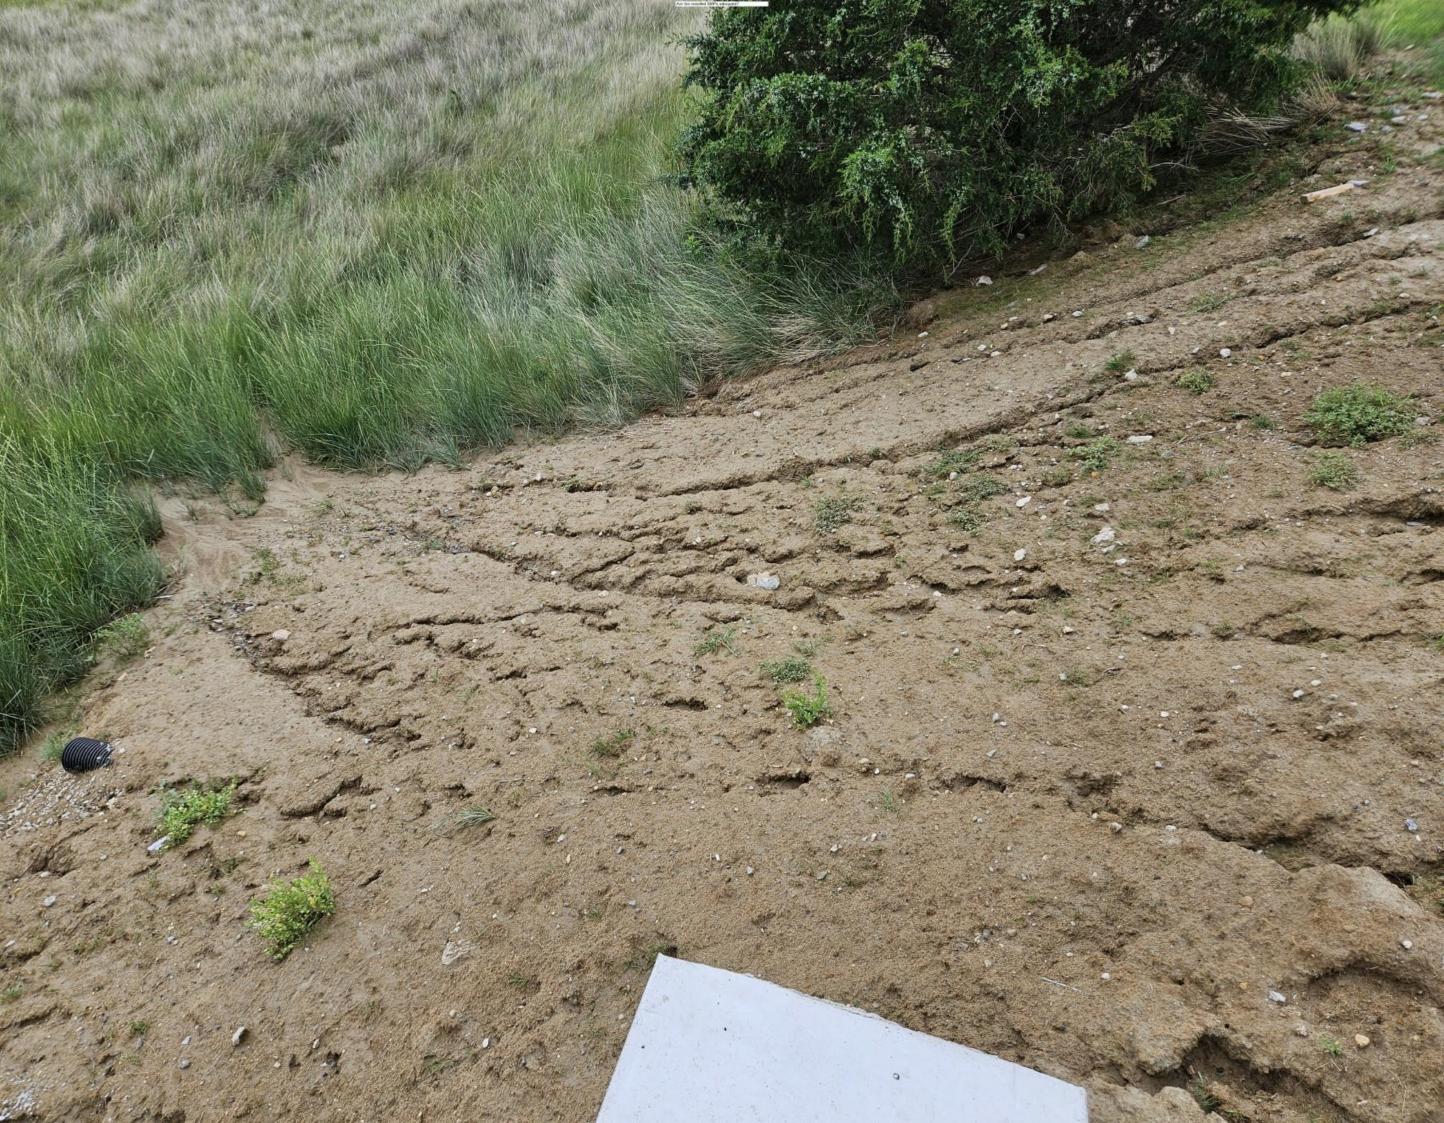
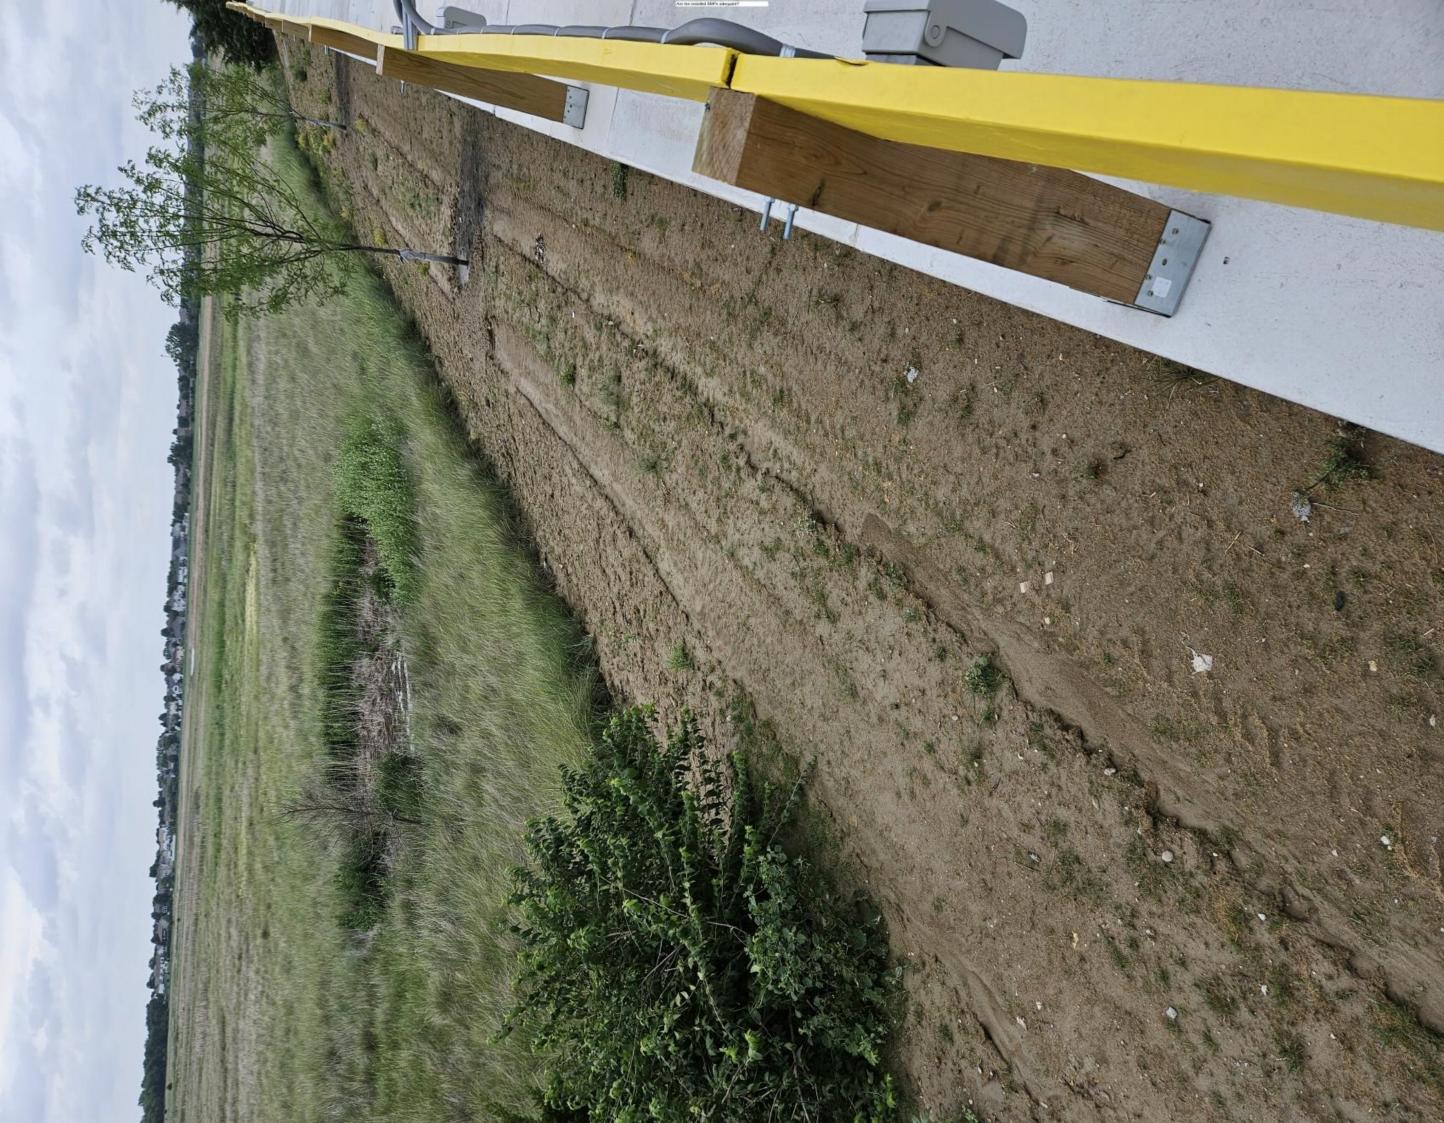
| Item<br># | BMP/activity | Implemented | Corrective<br>Action<br>Required | Location & Corrective Action Needed | Corrective Action Date Identified |
|---|---|---|---|---|---|
| 3 | Are the BMPs installed adequate? | no | yes | The majority of the hydroseed that was placed along the east side of the lot (along the east side of the retaining wall) appears to have been washed away. Very little, if any grass is growing since it was hydroseeded numerous weeks ago. Due to the rainfall on Tuesday July 4th, numerous rills have now formed and sediment appears to be going in to the neighboring grasslands in areas. Corrective Action: The area needs re-stabilized. Re-seeding is suggested. | 7/5/2023 |
| 5 | Are natural resource areas (waterways, wetlands, etc.) protected with barriers or similar BMPs? | no | yes | As noted in item #3, sediment appears to be going in the neighboring grasslands on the east side of the property. Corrective action: The area needs to be re-stabilized. Re-seeding and erosion control blanket is suggested | 7/4/2023 |

| Item<br># | BMP/activity | Implemented | Corrective<br>Action<br>Required | Location & Corrective Action Needed | Corrective Action Date Identified |
|---|---|---|---|--|---|
| 17 | Are all seeding requirements properly implemented? | no | yes | Re-stabilization and re-seeding along the east side of the property (east side of retaining wall). Erosion control blanket is also a suggestion. | 7/4/2023 |
